Mitigation best practices

Building codes helped Bolivar Peninsula homes survive

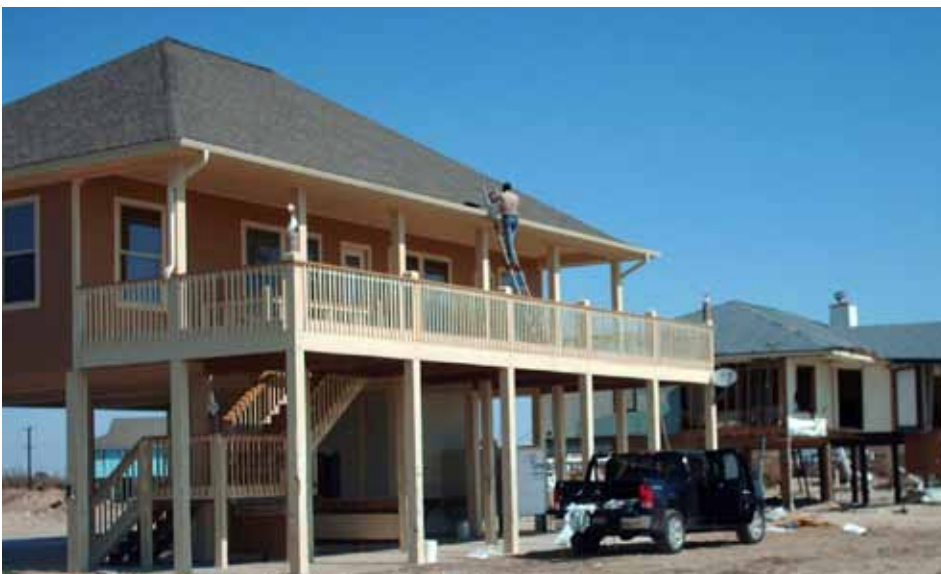
Jimmy and Debbie Bishop's house survived Hurricane Ike nearly unscathed. Their neighbor's older home, pictured on right, was built 4 to 5 feet lower and was significantly damaged.

Jimmy empathizes with his neighbors. “Next door, our neighbor’s house is older and probably 4 to 5 feet lower than ours. It took the surge and the waves, and the beach side of it is totally gone. It may have to come down,” he said. “We feel for these people.”

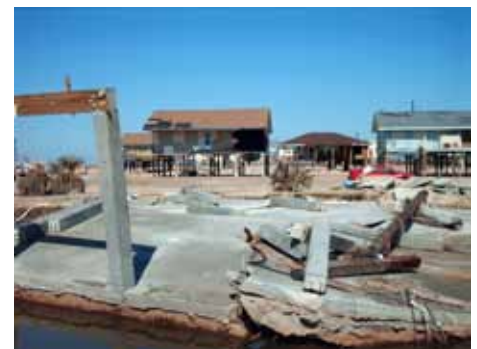
Bolivar destruction Photo by Roy Tyson/FEMA

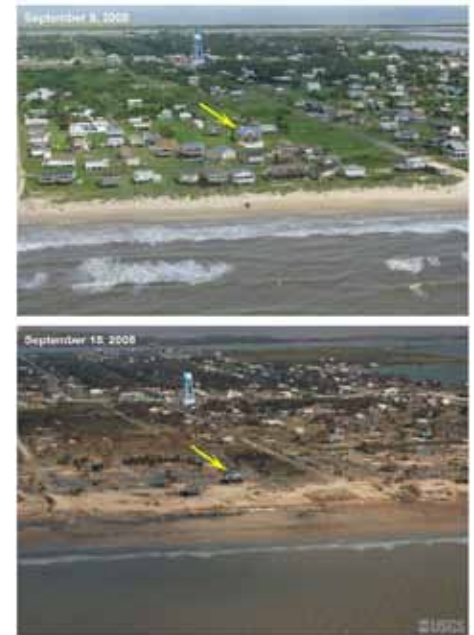
Bolivar before and after Ike Photo by USGS
