Disaster Mitigation Working in Pennsylvania

Audenreid Tunnel Treatment System

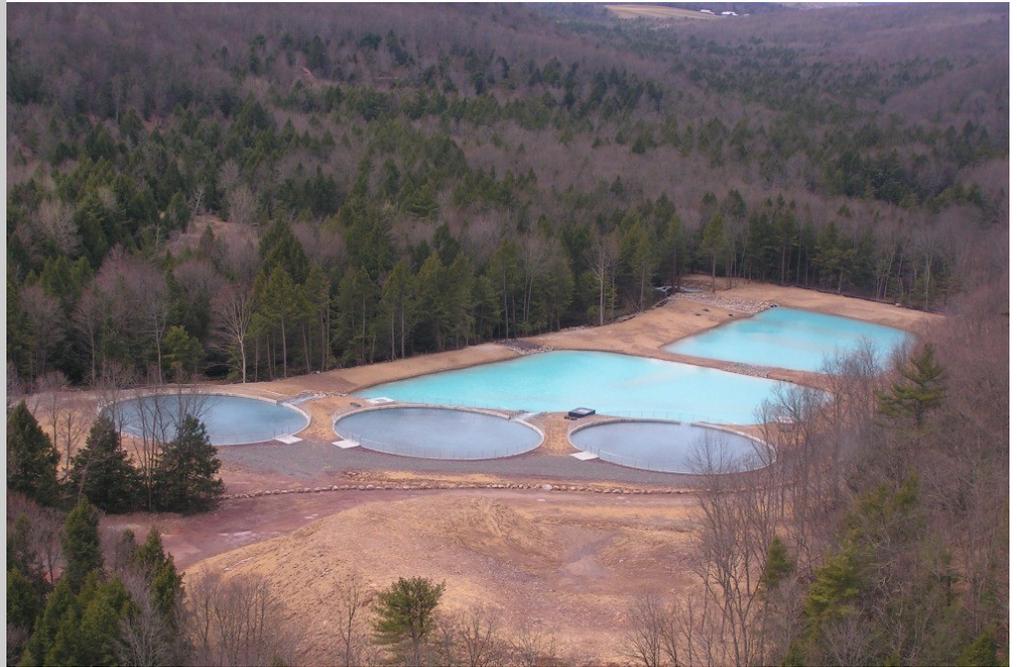
Audenreid Tunnel after blowout

Completed repairs and re-grading

The tunnel typically discharges about 8,500 gallons per minute, but it's a large tunnel, 12' wide by 9' high, and can roar with 300,000 gallons per minute during periods of intense rain. A severe storm in 2006 caused the face of the hillside above the outlet to come down in an avalanche of rock and debris, burying part of the treatment facility under tons of material and leaving an unstable cliff.

In the aftermath of this event, the Federal Emergency Management Agency (FEMA) and Pennsylvania Emergency Management Agency (PEMA) worked together to coordinate delivery of \$1.8 million in funding for repairs. FEMA Public Assistance (PA) funding is typically used to help state and local governments repair disaster damaged roads, bridges, public buildings and so on. Sometimes additional project element investments can help limit or prevent future damage. The re-grading and terracing above the mine drain outlet was a somewhat unusual example of a repair and hazard mitigation project. It came with major engineering challenges, but protecting the Audenreid Tunnel Treatment System is extremely important for the future of the region.

The repair work was completed in 2009 and has been tested by subsequent storms, including 2011 Hurricane Irene and extreme rainfall during Tropical Storm Lee. Schuylkill County Natural Resource Specialist Wayne Lehman reported that, "Once the flooding passed, the treatment system was able to restart. The massive repair project successfully protected the facility."
