Mitigation best practices

Hazard mitigation saves historic Galveston home

Laminated safety glass protects stained-glass window

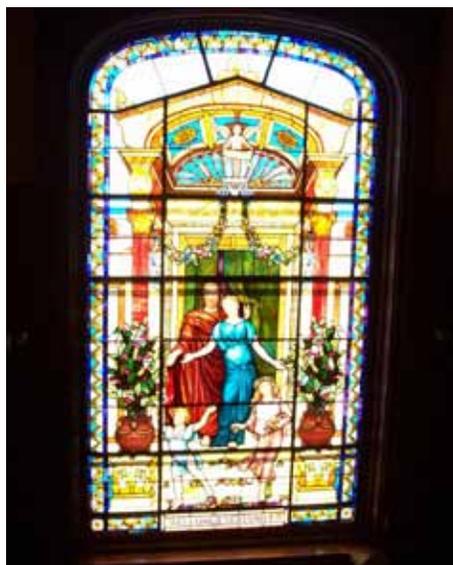
A 12-foot-tall stained glass window welcomes visitors to the Moody Mansion. Photo: Charles Black/FEMA.

Perhaps the most stunning feature is a 12-foot-tall leaded, stained-glass window overlooking the landing of the finely crafted staircase in the oak-paneled central hall. The glass portrays a family greeting visitors while a banner proclaims, "Welcome ever smiles."

During Hurricane Ike, winds hurled debris broadside into the stained-glass window. Was it another tragedy of the storm? No.

"Thank heavens, we had covered this special window outside with laminated glass to protect it in a storm," said Mary Hoehne, Moody Mansion facility man-

ager. The laminated glass, which had been replaced in recent years, has a network of spider cracks, clearly recording the debris' impact. "The covering did its job. There's no question that without the laminated glass we would have lost that window," she said.
