Mitigation best practices

Homes Built on Slab Foundations Can Be Elevated Too

Texas couple elevates home built on slab foundation in unusual do-it-yourself home project

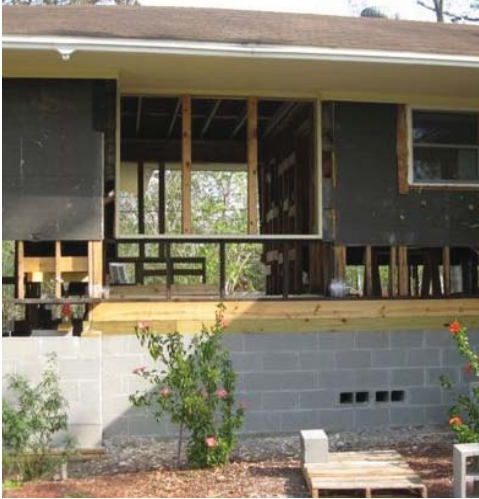
Cement block chain-wall used for elevation.

Within a few weeks, the McClouds had elevated the home the required 4 feet. The plans called for cement block columns and a cement block chain-wall to support the structure. Temporary blocks were put in place until a professional mason could complete the project.

Peter and Jessica followed the hazard mitigation concept of a continuous load path in their design plans. This calls for a continued line of connecting strength to all parts of the structure. It starts with rebar below ground. The rebar is fastened to the blocks above ground, which are strapped by metal braces to the frame of the house. The final support is completed with hurricane straps that attach the frame to the roof. This continuous load path, as well as replacing their 1950s windows with impact resistant glass, will help provide strength for their home to withstand enormous wind and water pressure from storms.

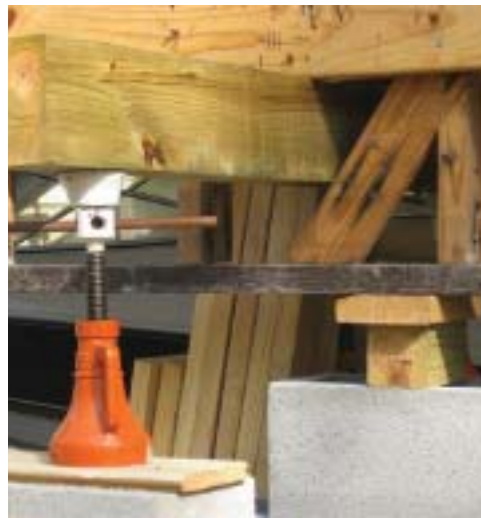
5 Ton Screw Jack used to elevate the McCloud's house.

A mathematical formula had been used to determine the number of jacks needed to lift the 70-ton house. The equation showed that 15 jacks were needed, but the McClouds decided to go well above that. To lift the house, 75 5-ton screw jacks were placed under the braces.

the jack to keep count." Peter explained that with three full turns of the jack the house was raised by a quarter of an inch. With this simple process they were able to systematically raise the house while keeping it level. As the workers raised the home, Peter and his father kept a constant watch to make sure it remained level as it was raised.
