Mitigation best practices

Quick reopening of supermarket served Galveston citizens

Seawall, structural measures, last-minute prep protected Kroger

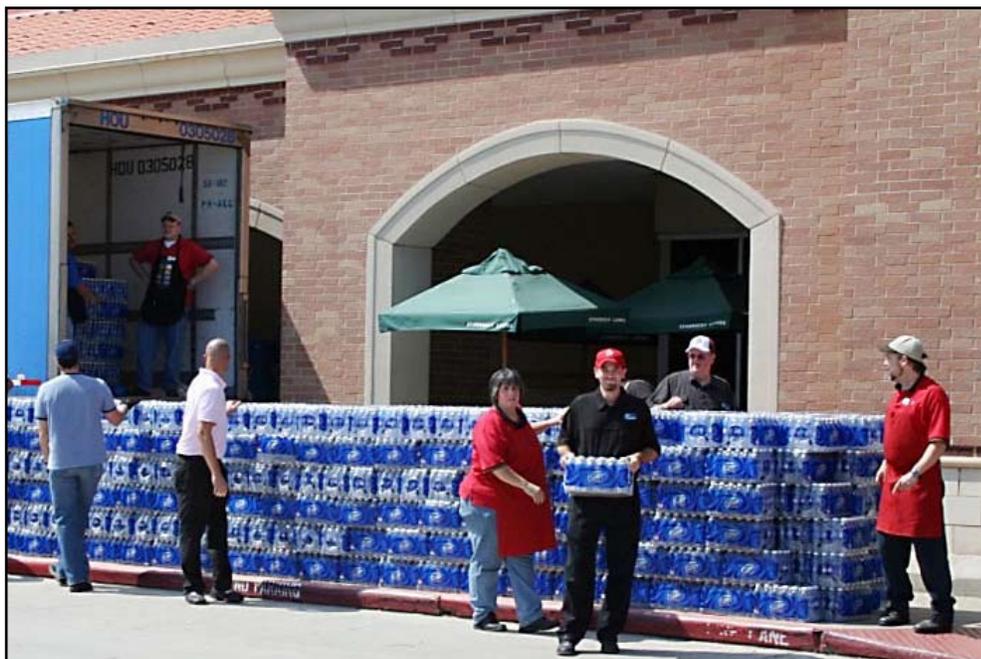
Kroger's grocery in Galveston opened quickly after Hurricane Ike because of hazard-mitigation actions.

Hearing explained that the store, built in 2000, “was designed to have water roll to the left and the right, so the store wouldn’t be impacted so much.”

He also said, “When they built this store, they brought in extra fill to raise the lot, built up more on a concrete pad and raised the store quite a bit. We have a disaster plan, but everything hinges on the physical structure of the building, whether anything survives or not.”

The sturdy masonry structure complied with all building codes when the structure was built, said David Ewald, City of Galveston building official. In fact, the structure was built more than two feet above the height required by floodplain regulations, according to Kroger officials.

Kroger’s staff conducted a blitz of preparedness activities before the storm hit. “We had shutters on all our windows — which were already protected by a masonry-columned promenade — sandbagged the doors and put heavy pallets of merchandise on our bay doors to keep them from blowing in,” Hearing said. “What we did is like the normal precautions you would do at your house before a storm, but on a little larger scale.

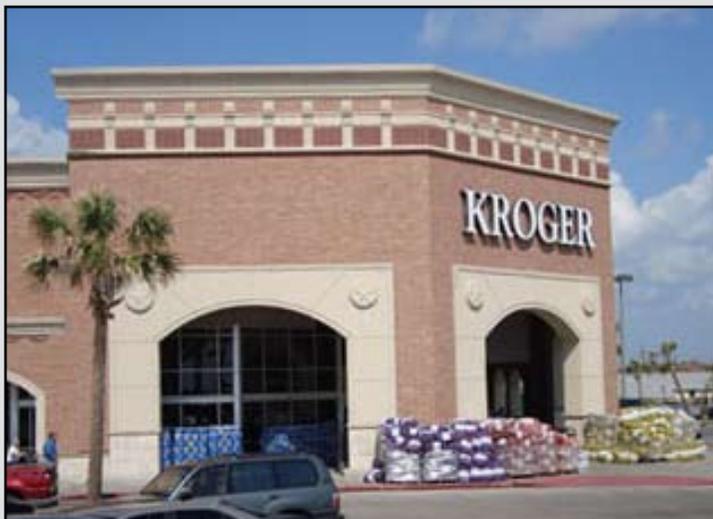
Signature Kroger grocery store, Galveston, Texas.
